Section L (Wheels and Tyres)

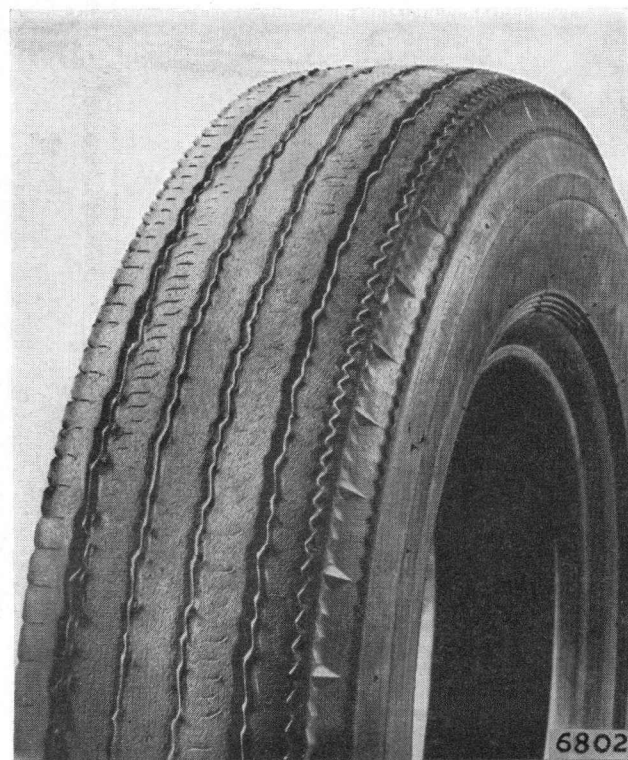
Fig. 2. Fin and feather wear due to extreme wheel misalignment.

The tyre tread having been scrubbed off laterally is caused by wheel misalignment. An upstanding sharp fin on the edge of each pattern rib is a sure sign of misalignment.
